HOW TO AVOID SMALL AREA STAINS AND BLEMISHES

**in the Design, Installation
and Use of Indiana Limestone**

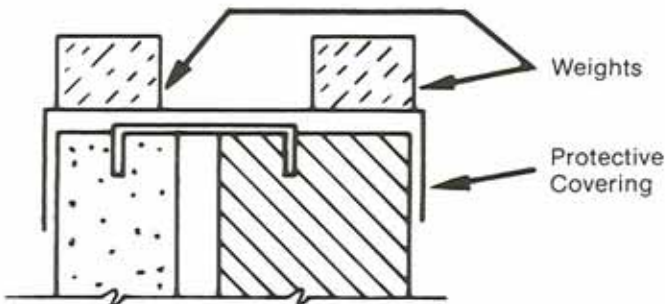
Natural Characteristics

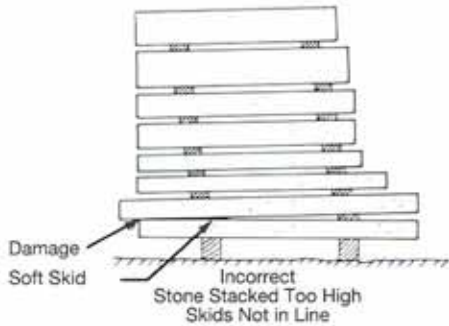
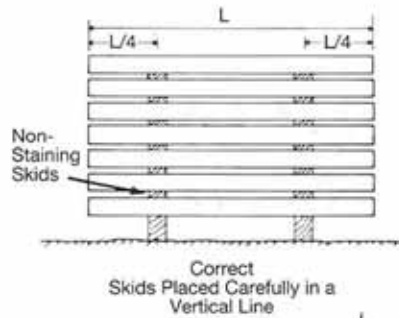
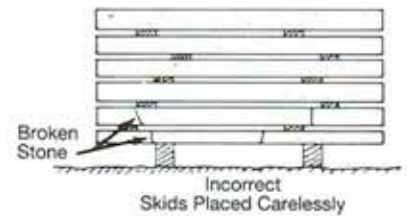
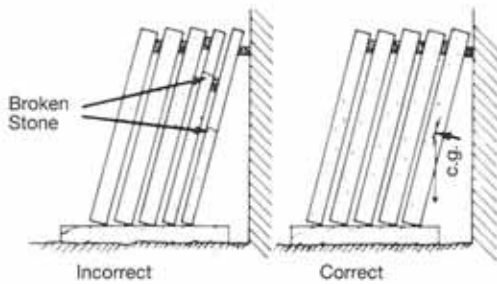
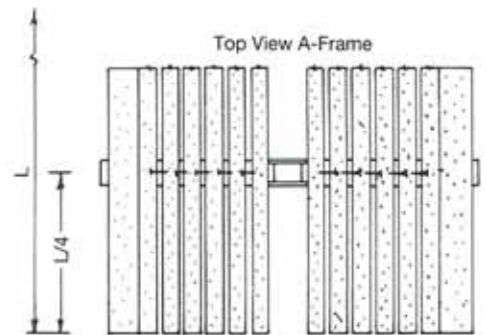
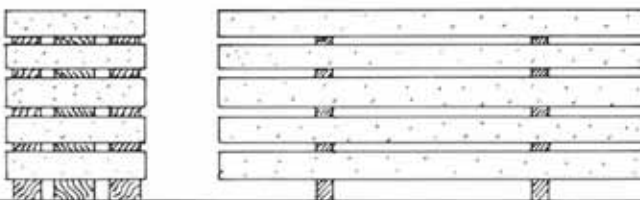
This Type Good for Irregular Ground

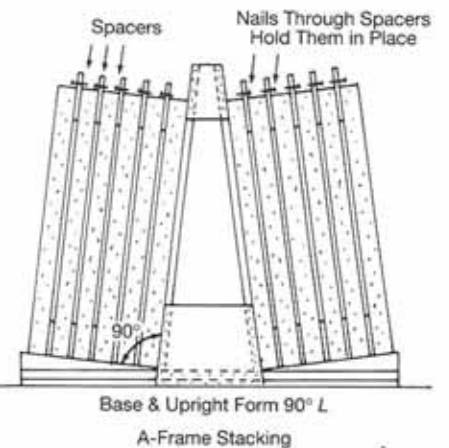
ture is breathed away by the stone. The time required for complete clearing of internal moisture varies with building type and shape, types of joints, number of weep holes or wicks, weather conditions and a number of other factors. But the refractive changes in the stone's surface caused by wetness will eventually disappear.

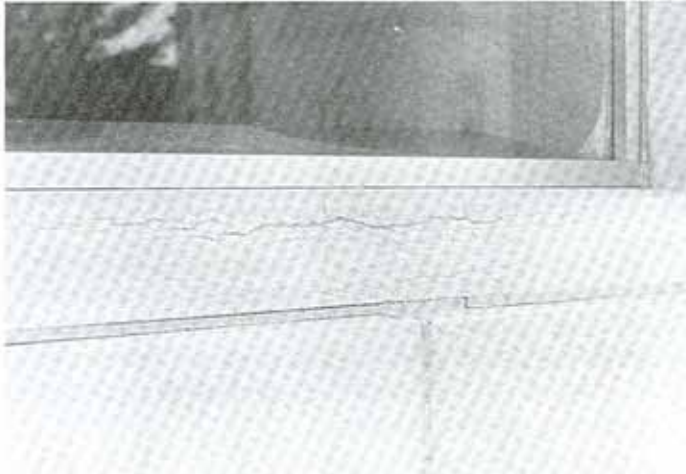
This is a typical example of the damage caused by unskilled workers using sandblast to clean Indiana Limestone.

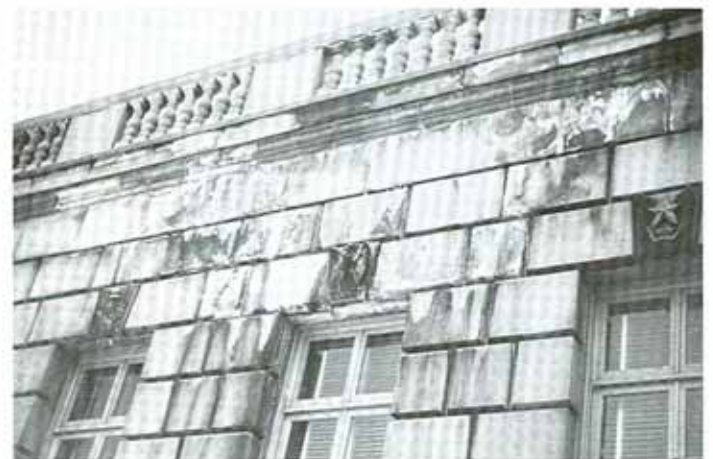
A badly leaking roof caused this eyesore. When the leaks were repaired, the efflorescence cleared up within a few months.

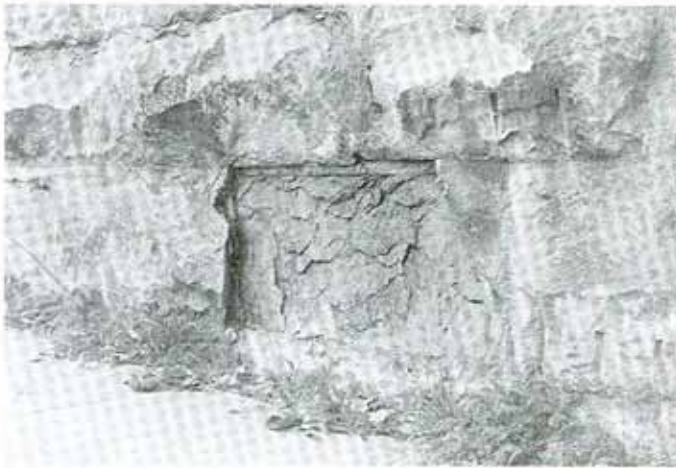
Typical sheeting in exfoliating limestone at the base course of a retaining wall (ca. 1880). The stone is sluffed off in thin layers. Compare to exfoliation in concrete shown in the following photograph.

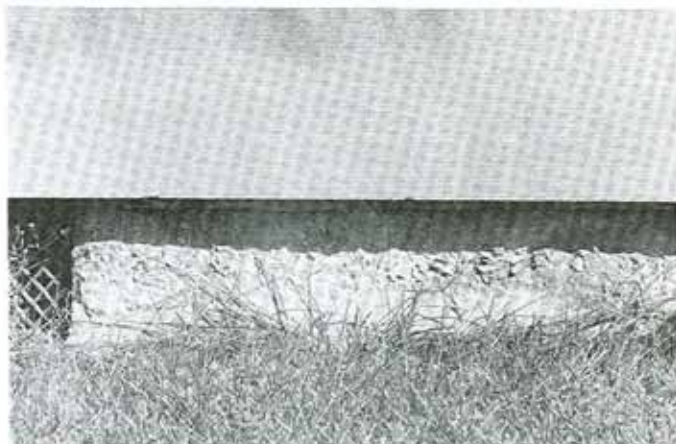
This limestone basecourse has been protected from water absorption by a setting bed of waterproofed mortar between it and the concrete foundation. (ca. 1930)

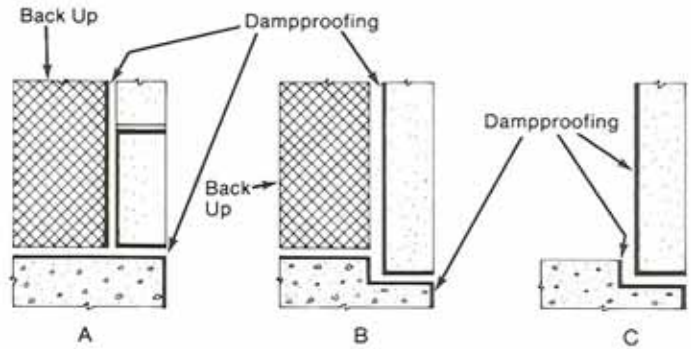
Clogged weep holes often may be opened or new weeps installed where none previously existed to relieve the problem. Felt wicks serve the same purpose and may be more effective, in that they cannot be closed by dirt accretion or insects. By whatever procedures, the source of water should be eliminated, and the dampproofing materials applied where stone backs can be reached.

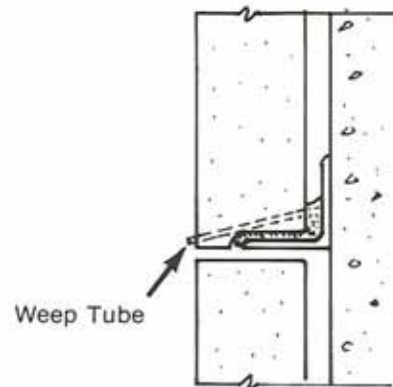
Exfoliation and major efflorescence are evidence of problems which may require specialized diagnosis and treatment.

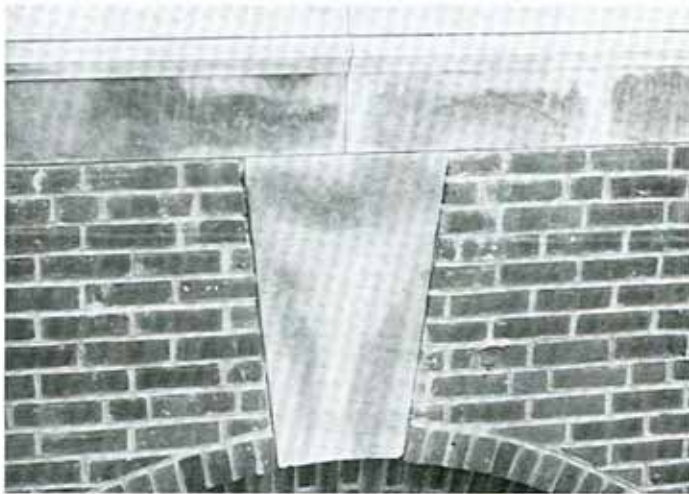
Alkali stain. An overnight rain produced this condition in an untopped, uncovered wall. The stain disappeared in a few months.

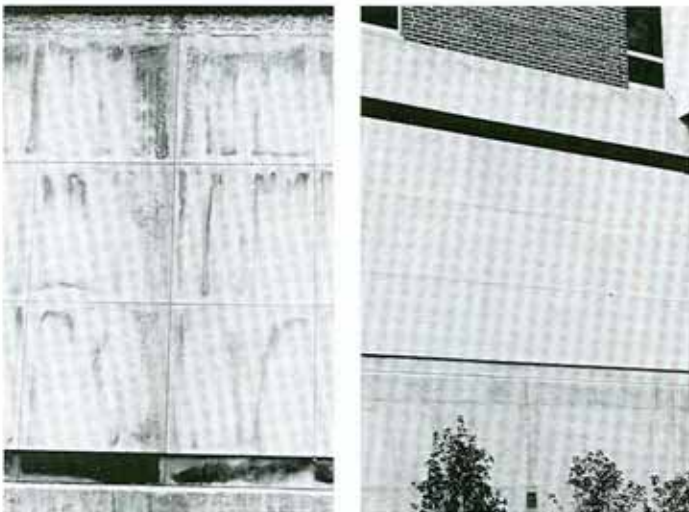
Before & After photos of an intense alkali stain condition. Note the extremely dark stones above the floor spandrel. This stain cleared to the "After" condition within 18 months.

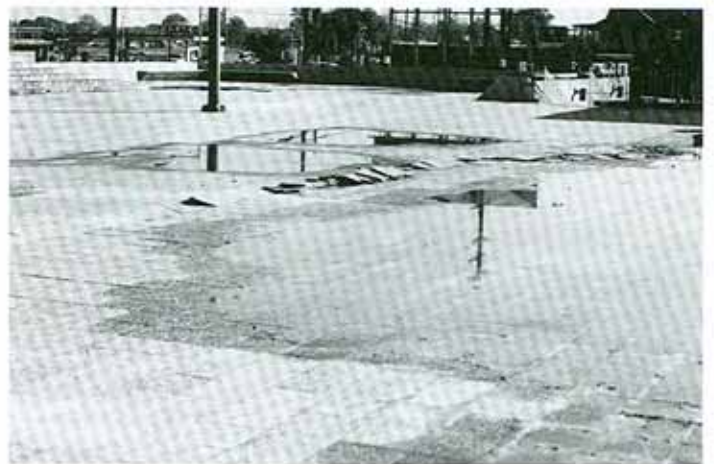
Improperly designed or constructed decks produce conditions leading to stain, efflorescence and exfoliation in any fascia material at their perimeters. In such extreme situations, damp-proofing as discussed in the text may fail, and physical isolation of the lower fascia from resultant leaks will be the only way to avoid problems.

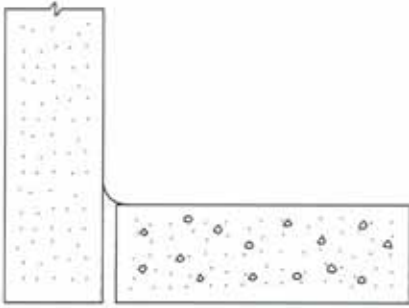
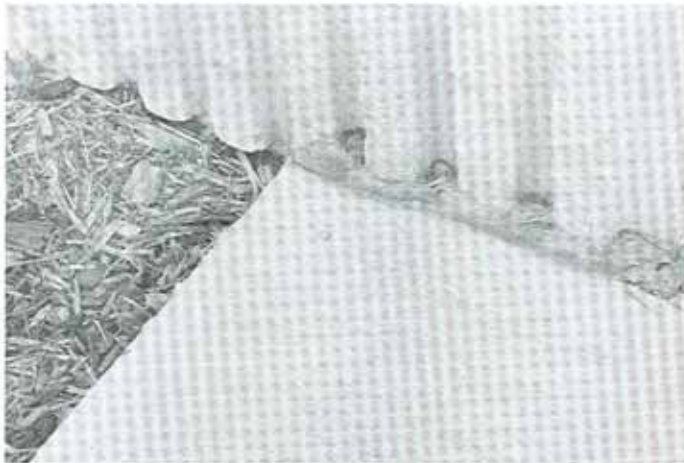
Although poorly tooled, this sealant "cove" between paving and stone face is an effective barrier to moisture absorption.

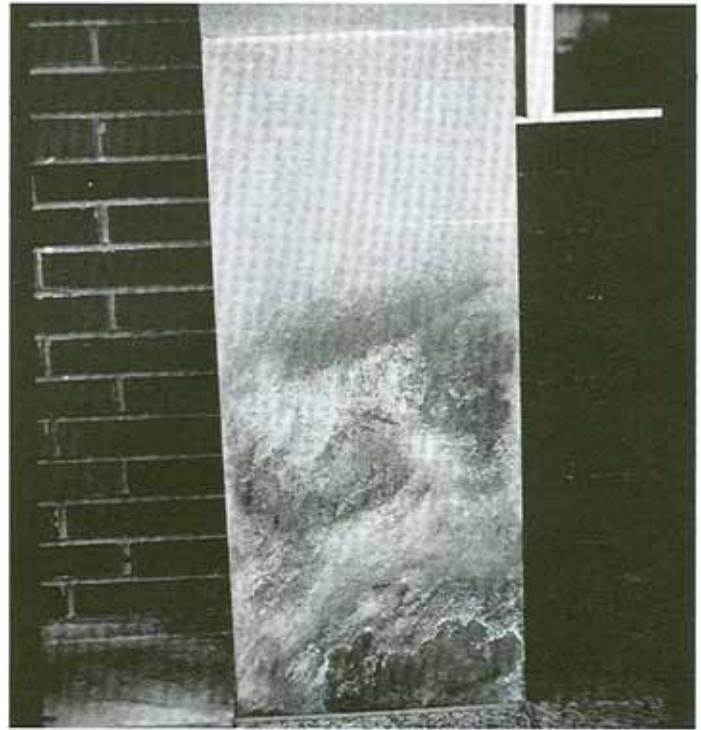
A typical efflorescence pattern on Indiana Limestone. Here it is shown superimposed on an alkali stain.

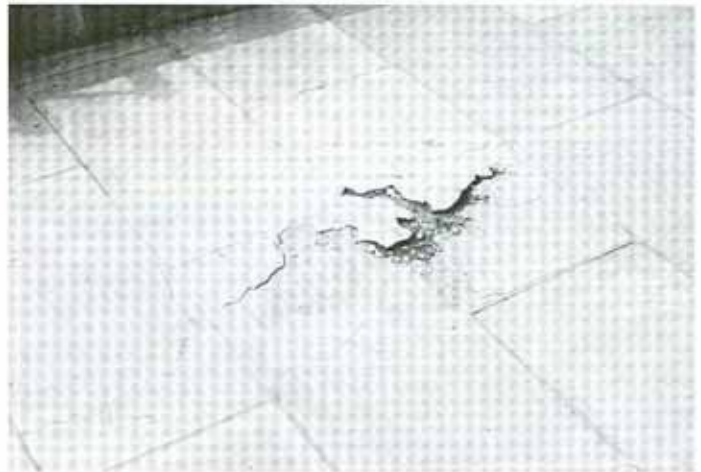
Over relatively few years, a snow-removal program using salt produced this deterioration on walkway paving.

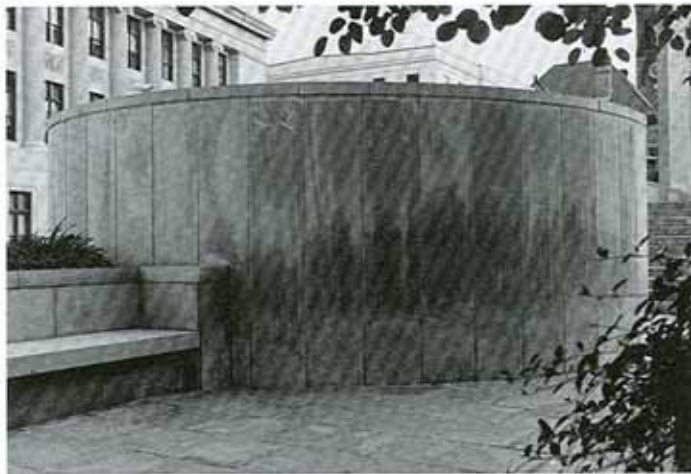
A combination of absorbed salt solutions and unprotected stone backs in a planter area produced this discoloration.

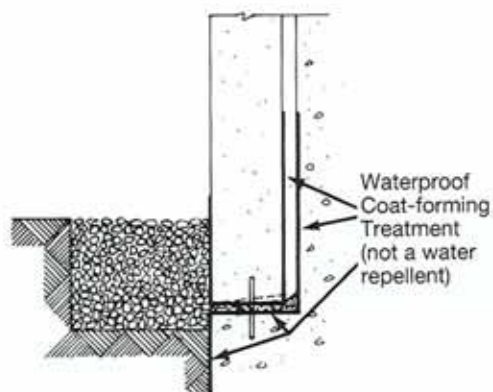
Clear water repellents should not be used on stone backs or under grade.

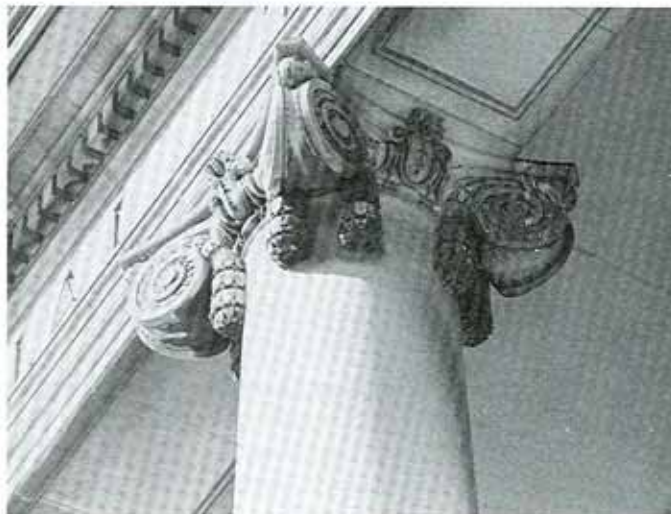
The lower areas of the volutes on this Ionic cap are protected from weathering. The resultant encrustation from years of soot could be greatly lightened if not entirely removed by scrubbing.

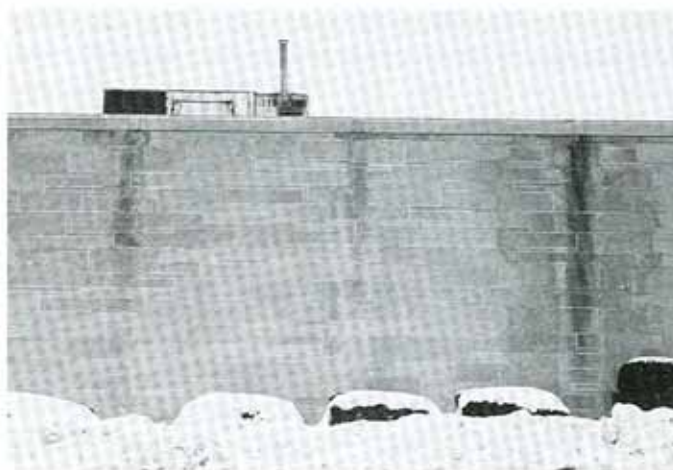
Leaking connections in this metal coping collect water and dirt which flood over the stone below in a concentrated flow.

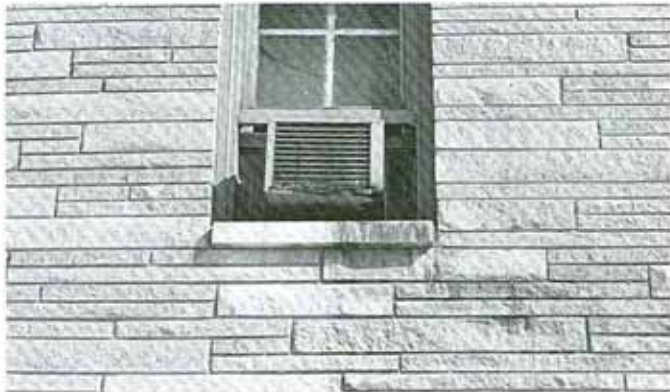
Lack of maintenance on this air conditioner has produced a badly stained sill and other stones in the splitface wall below.

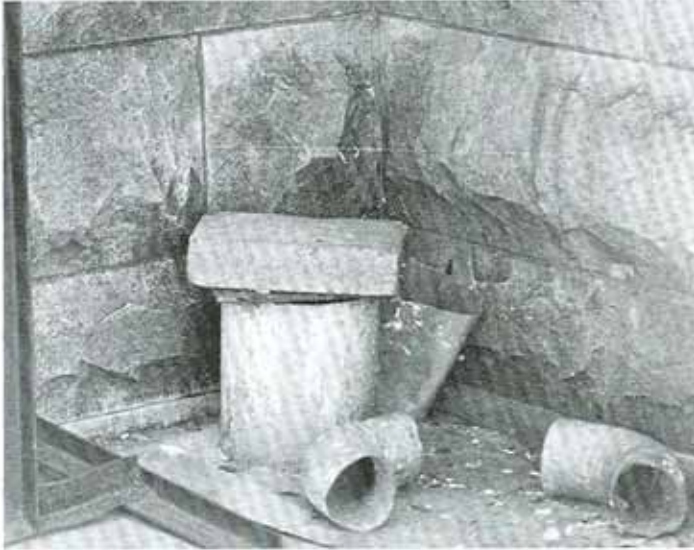
This corner area provides the necessary conditions for a growth of moss. Other vegetable growth may develop with the added nutrients of droppings.

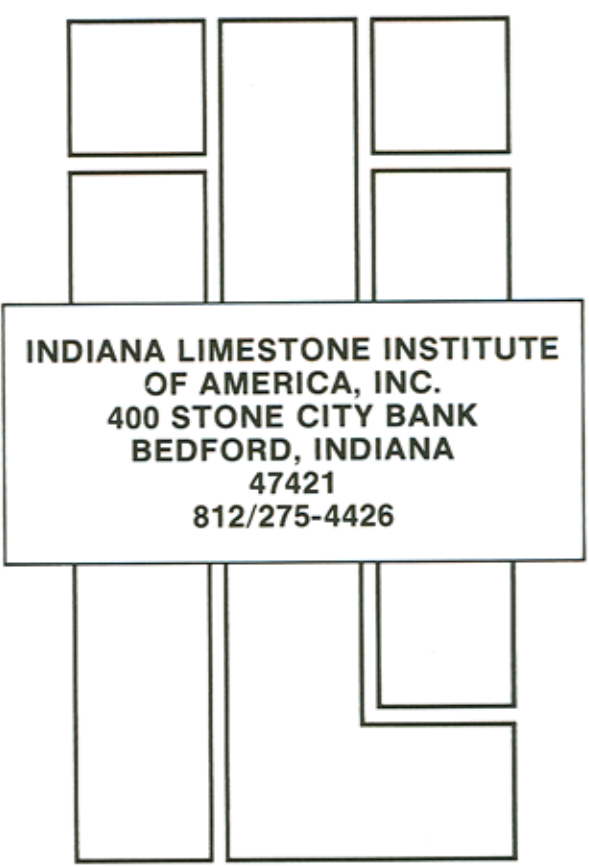
**INDIANA LIMESTONE INSTITUTE
OF AMERICA, INC.
400 STONE CITY BANK
BEDFORD, INDIANA
47421
812/275-4426**
